Extensor Mechanism Complications After Patellar Resurfacing in Knee Replacement – Can They Justify Non-Patellar Resurfacing?

Antonio Silvestre, Raúl Lopez, Fernando Almeida,
Pablo Renovell, Francisco Argüelles and
Oscar Vaamonde

<http://dx.doi.org/10.5772/53382>

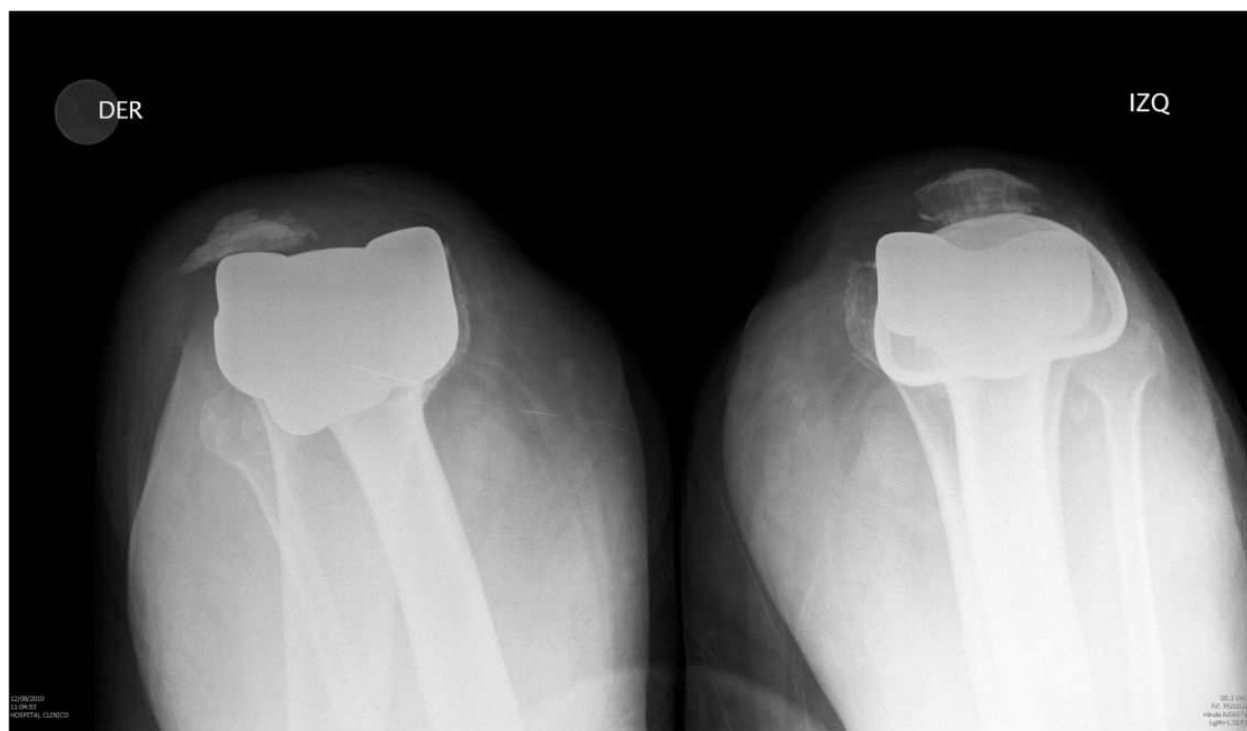
Figure 1. Advanced-age patient suffered subluxation of the extensor mechanism due to a patella infera, after total knee replacement. It was well tolerated; orthopedics measures were employed (a brace and avoiding activities that aggravate instability)

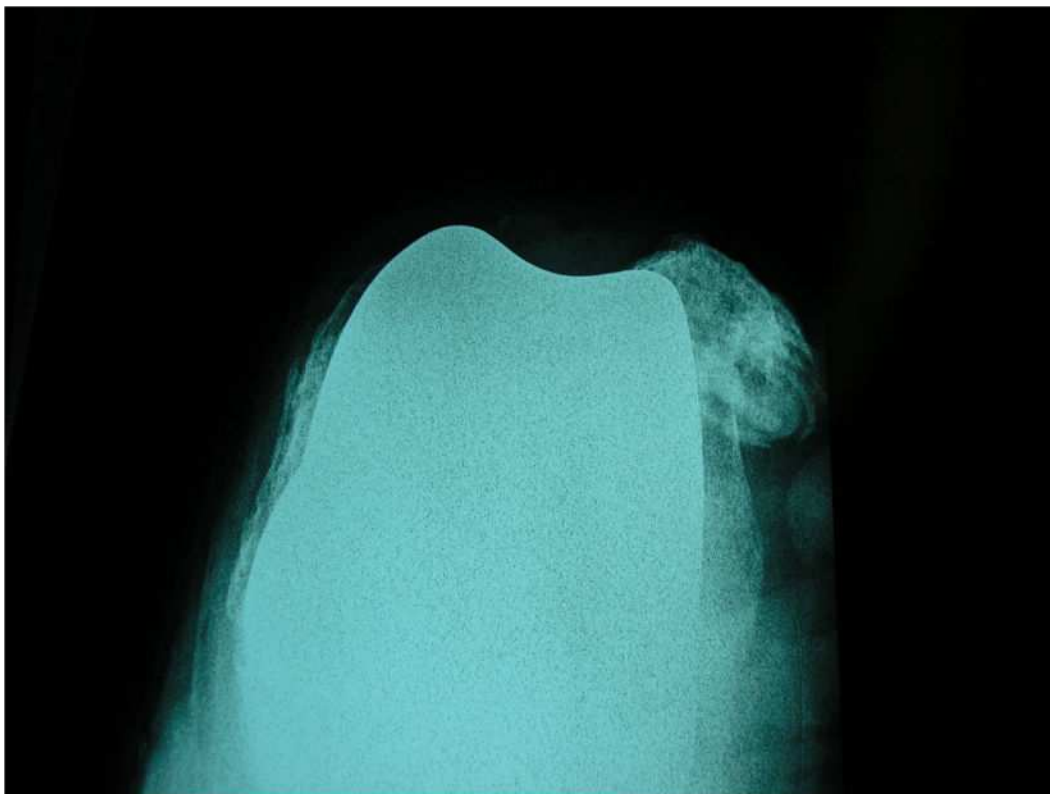
Figure 2. Frank dislocation of the patella who required revision surgery. Internal rotational alignment of the femoral component made us to revise it, getting good functional outcome after surgery.

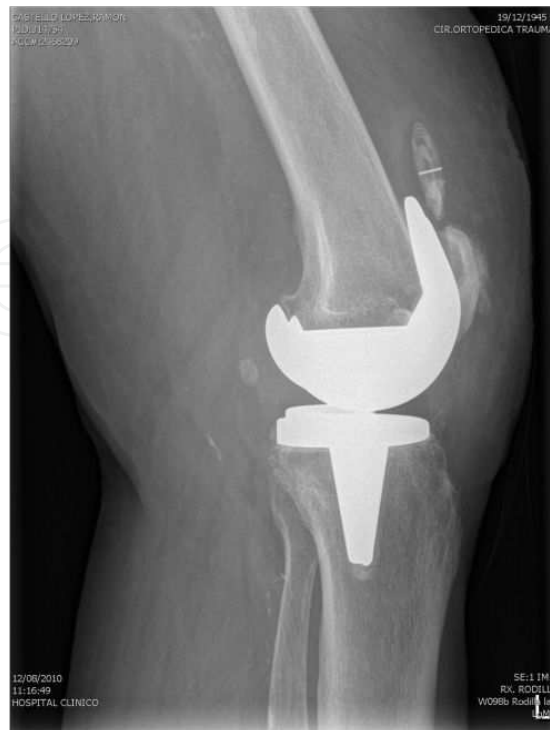
Figure 3. Loosening of the patellar insert that required removing of the polyethylene. As quality of remaining bone wasn't good, no other all-polyethylene implant was placed

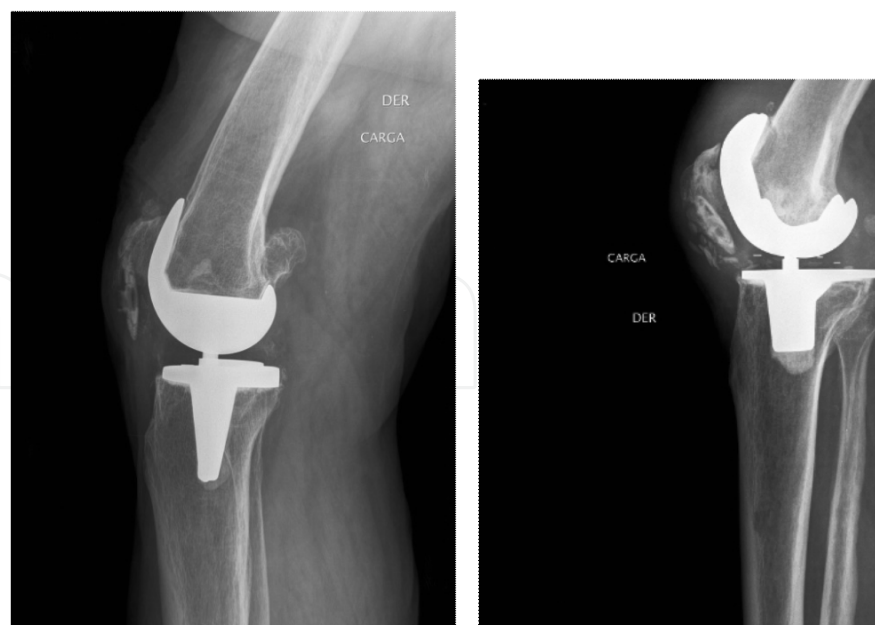
Figure 4. Two examples of fracture of the patella with loosening of the patella. The patients referred a previous trauma in both cases and revision surgery with extensor mechanism reconstruction was done.
